#### COMPLIANCE EVALUATION INSPECTION REPORT

Compliance Evaluation Inspection: Chenango County Landfill

Inspection Date: July 17, 2014 Inspection Time: 10:30 AM – 3:00 PM

Site Information: Chenango County Landfill

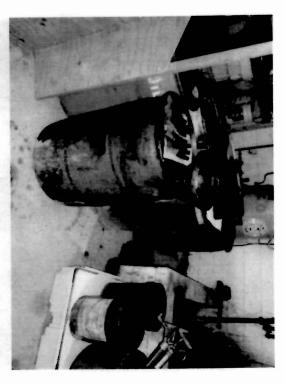
P7170304

4. As identified in photographs P7170299, P7170303 – P7170305, the following housekeeping concerns were identified in the maintenance garage on the west side of the Site: oil staining was observed on the floor; 55-gallon drums were not stored on spill pallets and were situated adjacent to a floor drain; and a notable amount of oil was observed in the secondary containment structure for the waste oil tank. According to Mr. Loomis, the floor drains in the maintenance shop flow to a septic tank that outlets to the leachate collection system.

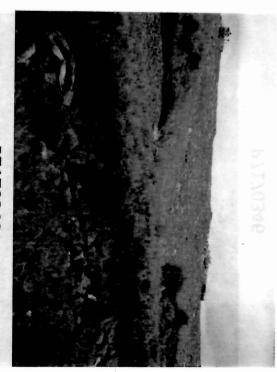
P7170340

- c. Among other things, Part 3.7 of the SWPPP states that the Facility is inspected daily for garbage, waste and floatable debris, and any waste identified onsite is immediately picked up and placed in covered waste containers. As identified in photographs P7170344, P7170346 and P7170347, floatable debris was observed at the foot of the temporarily capped area up gradient of Pond B, where it can enter the drainage swale flowing to Pond B. Although the vegetative strip between the foot of the temporarily capped area and the swale provided a line of protection, some floatable material was observed in the swale at the time of the CEI (see photograph P7170340).

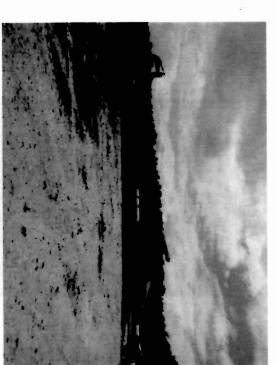
P7170312	Leachate loading dock and rinse area (collected rinse water is pumped back into
	leachate collection system)
P7170314	Eutrophication next to outfall structure in Pond A
P7170316	Outfall 001 from Pond A (green algae observed in discharge)
P7170317	Unnamed tributary of Fly Meadow Creek near outfall 001
P7170319	Compost pile next to Pond A
P7170320	
P7170328	Uncovered scrap metal dumpster
P7170329	Uncovered scrap metal dumpster
P7170334	Refrigerators and air conditioners stored on the pavement near the scale house
P7170335	Outfall 002 from Pond B
P7170337	Flow path from Outfall 002 south towards the unnamed tributary of Fly Meadow
	Creek
P7170338	Outfall structure in Pond B
P7170340	Floatable debris (bags, wrappers) identified in the drainage ditch upstream of
	Pond B
P7170344	Floatable debris at the foot of the temporarily capped area up-gradient of the
	drainage ditch flowing to Pond B
P7170346	Close-up of floatable debris at the foot of the temporarily capped area with

proximity to the drainage ditch; Pond B identified in photo background
P7170347	Close-up of floatable debris with proximity to drainage ditch
P7170351	Stone crushing activity in overburden area on the north side of the Site
P7170352	Area down-gradient of overburden area on the northwest side of the Site (near
	maintenance garage)
	manney and burney

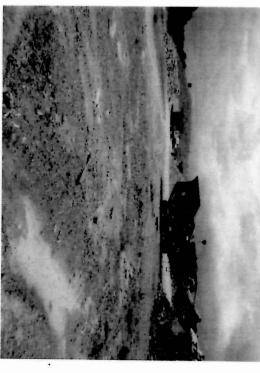
P7170352

Accumulated sediment in perimeter drainage swale down-gradient of overburden
area; stormwater conveyed in drainage swale eventually flows to Pond A;
unstabilized entrance to overburden area identified in photo background.
Downstream end of culvert pipe beneath unstabilized entrance identified in photo
P7170353. Sediment/turbid drainage observed in the swale.
Accumulated sediment identified in the perimeter drainage swale down-gradient
of overburden area.
Stormwater basin located north of Cell No. 3 on north side of the Site. Stormwater
is pumped from a low sump area on the west side of the basin and discharged to
the perimeter drainage swale, which conveys flow to Pond A.
Manhole located near maintenance garage identifying what is believed to be the
septic tank outlet connection to the leachate collection system.
